DS9400 Series

EN | Release Notes for Firmware V2.07
Fire Alarm Control Panel

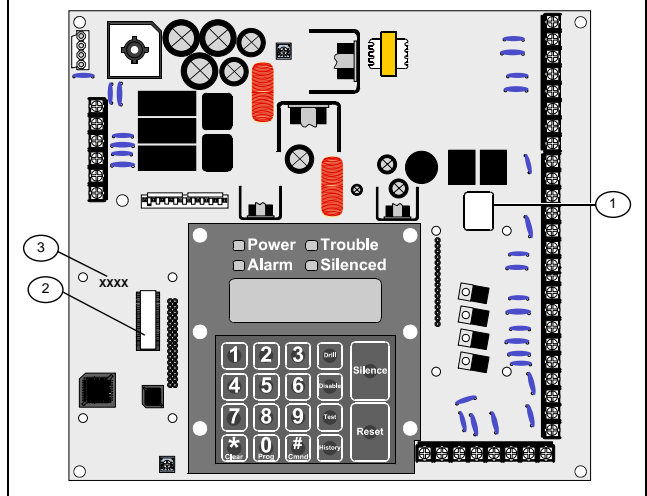
Figure 1: Firmware Version Label and Date Code Locations

Boards shipped before August 31, 1999 must be modified according to Technical Service Note (P/N: 42363) to ensure that the battery test runs properly. Affected boards carry a lot number of 99 or lower and a date code of 9935 or earlier. Boards shipped after August 31, 1999 with a date code higher than 9935 are unaffected. See Figure 1 on page 3 for the location of the lot number and date code.

- 1 Lot Number Label
- 2 Firmware Version Label
- 3 Date Code Stamp
